Control Column U-Joint Wear

Description: It has come to our attention that the universal joint (u-joint) at the forward end of the control column may have excessive play or wear that must be addressed. The following procedure will help identify the problem.

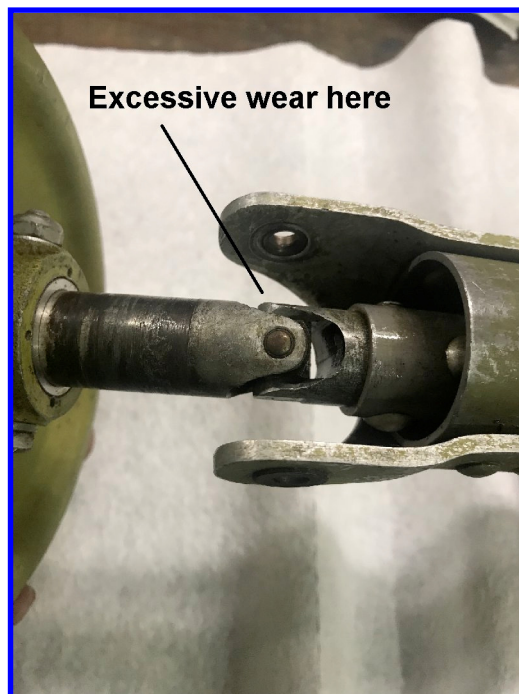
With the top glareshield covers removed, grab the aileron pulley on the forward end of the control column (This is the large pulley controlling the aileron cables). At the same time, turn the pilot's control wheel back and forth slightly, holding the pulley from moving, and note any play in the u-joint. If there is any play, conditions may exist that will cause a catastrophic failure of the aileron control system. Note: The elevator control may not be affected.

U-Joint on the forward end of control column

Procedure: If the wear, or "play", is excessive, the u-joint may need to be replaced. Get your mechanic to determine if the wear is out of limits. The original u-joint had no play at all when new and movement was smooth and precise so a replacement u-joint may be in your future. Finding a replacement may be a bit of a challenge as the original part number was UJ-388 from the Apex Machine and Tool Company in Dayton, Ohio. Below is the original Republic drawing:

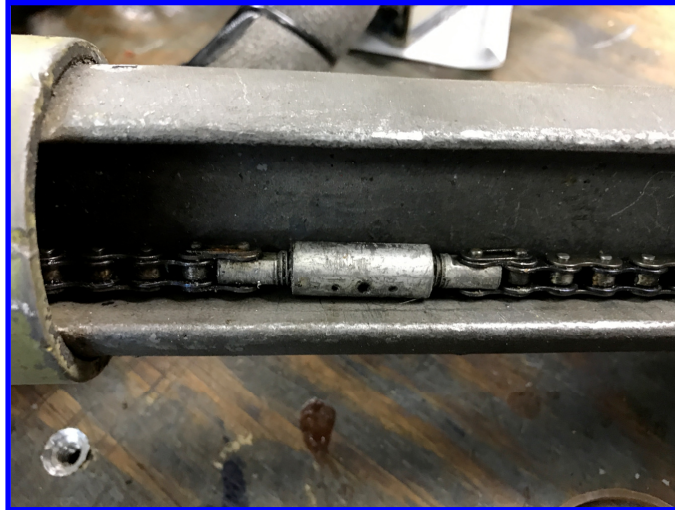
Control Arm cover removed showing turnbuckle and chain.
Safety wire removed.

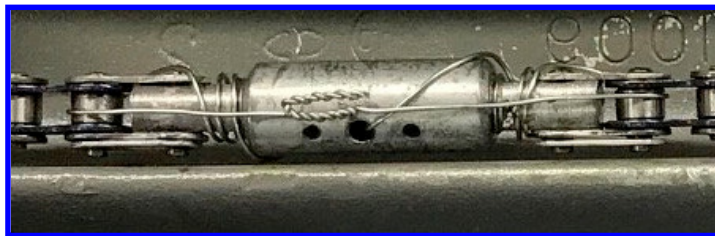
Turnbuckle and chain safety wire installed.
THIS IS REQUIRED!

Note: This is a great time to inspect the chain for wear. Clean the chain thoroughly with mineral spirits. The chain should not have any movement in the individual links when pulled lengthwise. Check for excessive wear on the links where the sprockets mate with the chain. If all is well, lubricate the chain by soaking it in oil. If replacement is necessary, the chain and links are available from a number of suppliers. (i.e.: McMaster-Carr.com)

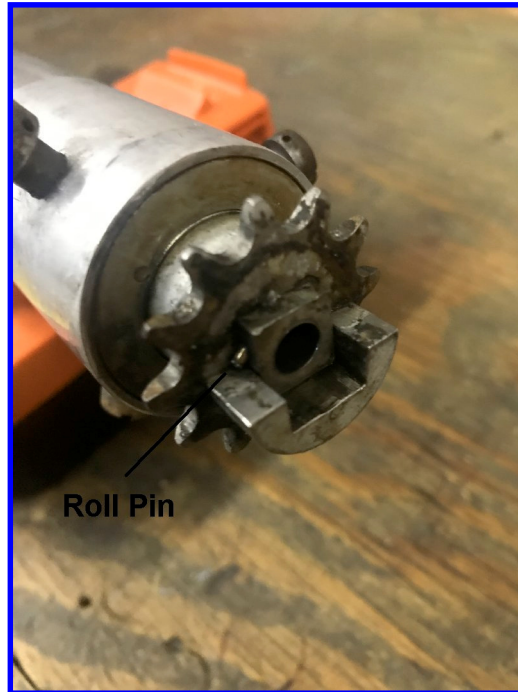
Torque tube end with sprocket. Note 1/16" roll pin.

- ☐ Remove the 1/16" roll pin (music wire) that is installed diagonally through the square drive. A pair of vise grips and/or a 1/16 punch may be necessary.
- ☐ Remove the inner torque tube from the outer push-pull tube.
- ☐ Drill out rivets holding the U-joint in place.
- ☐ Remove the U-joint

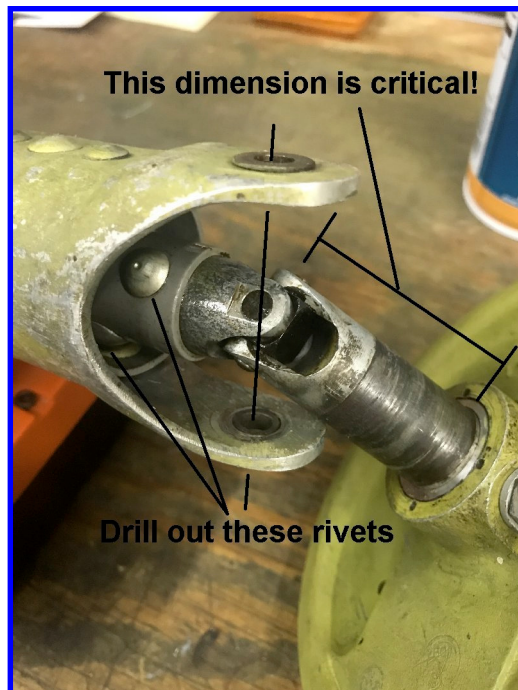
Rivets to be removed. Use AD rivets!
Note alignment of u-joint with pivot bolt holes

Install the new U-joint and drill torque tube end for the new rivets. Be sure the new u-joint pivot pins are in line with the bolt holes on the forward end of the push-pull tube. The aileron pulley end must also be drilled for the AN4-16A bolt. Make sure the pulley orientation and dimensions on the U-joint is the same as when it was removed! It appears that the aileron pulley bolt is in line with the u-joint pivot.

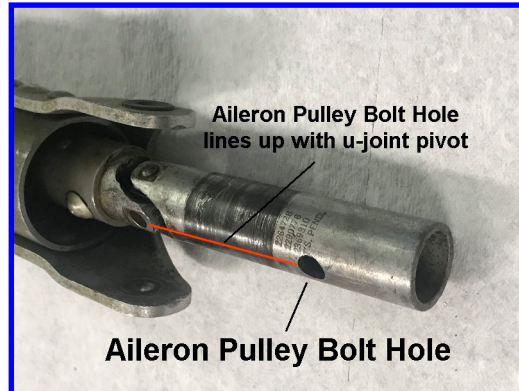
Orientation of aileron pulley bolt hole

Warning: Make sure the pivot point of the U-joint (where the U-joint block pins are) is inline with the two boltholes on the forward end of the outer push-pull tube! If not, there will be premature wear of the U-joint. Also make sure the aileron pulley is in the same location as when it was removed. The old U-joint can be used as a pattern.

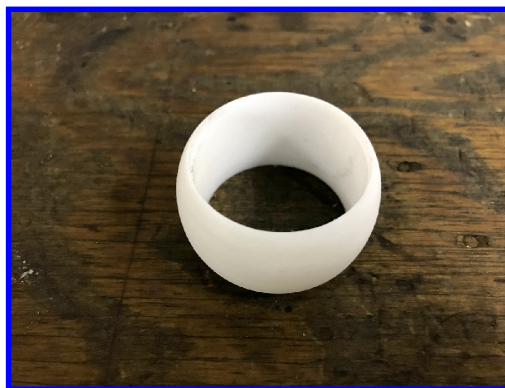
Teflon Control Tube Bearing

Side note: This may be a good time to replace the phenolic Control Wheel Tube Bearing (RPN 1163) that supports the Tube. There is Teflon replacement bearings available that make the Control Tube slide effortlessly through the instrument panel. No lubrication is needed nor wanted. You should also polish the push-pull tube to a mirror finish that will reduce the effort required to pull the controls aft plus, it really looks good when you are done.

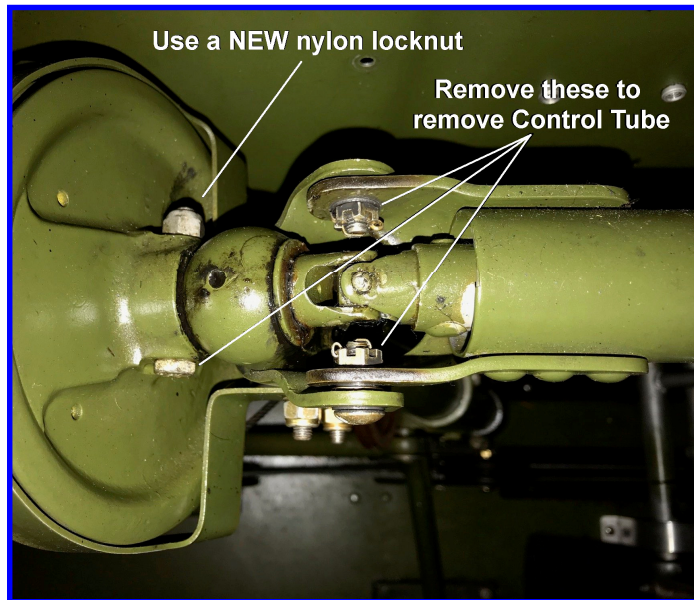
Below is a photo of the completed installation. Notice how the two bolts are in alignment with the U-joint pivot pins.

Control Tube shown in place. Three bolts will allow removal of Control Tube.
USE A NEW NYLON LOCKNUT ON THE AILERON PULLEY!
