REPUBLIC AVIATION CORPORATION
FARMINGDALE, LONG ISLAND, NEW YORK
SERVICE DEPARTMENT

SERVICE BULLETIN NO. 9

REWORK OF STARTER TERMINAL JUNCTION COVER ASSEMBLY

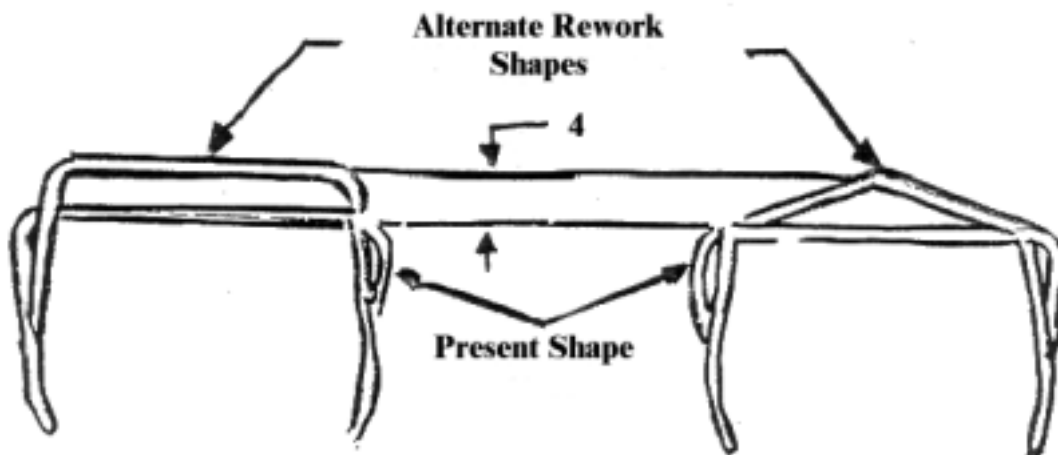
Reason for Change: To prevent the possibility of a short circuit occurring if the cover becomes dented.

1. Remove top and right hand side cowl.
2. Remove starter terminal junction cover and rework as shown on Figure 1 by bending.
3. Replace junction cover, top and right hand side cowl and make suitable entry in log book.
