SERVICE BULLETIN

REPUBLIC AVIATION CORPORATION
FARMINGDALE, LONG ISLAND, NEW YORK
SERVICE DEPARTMENT

SERVICE BULLETIN NO. 21

INSTALLATION OF PROPELLER SAFETY SPRING

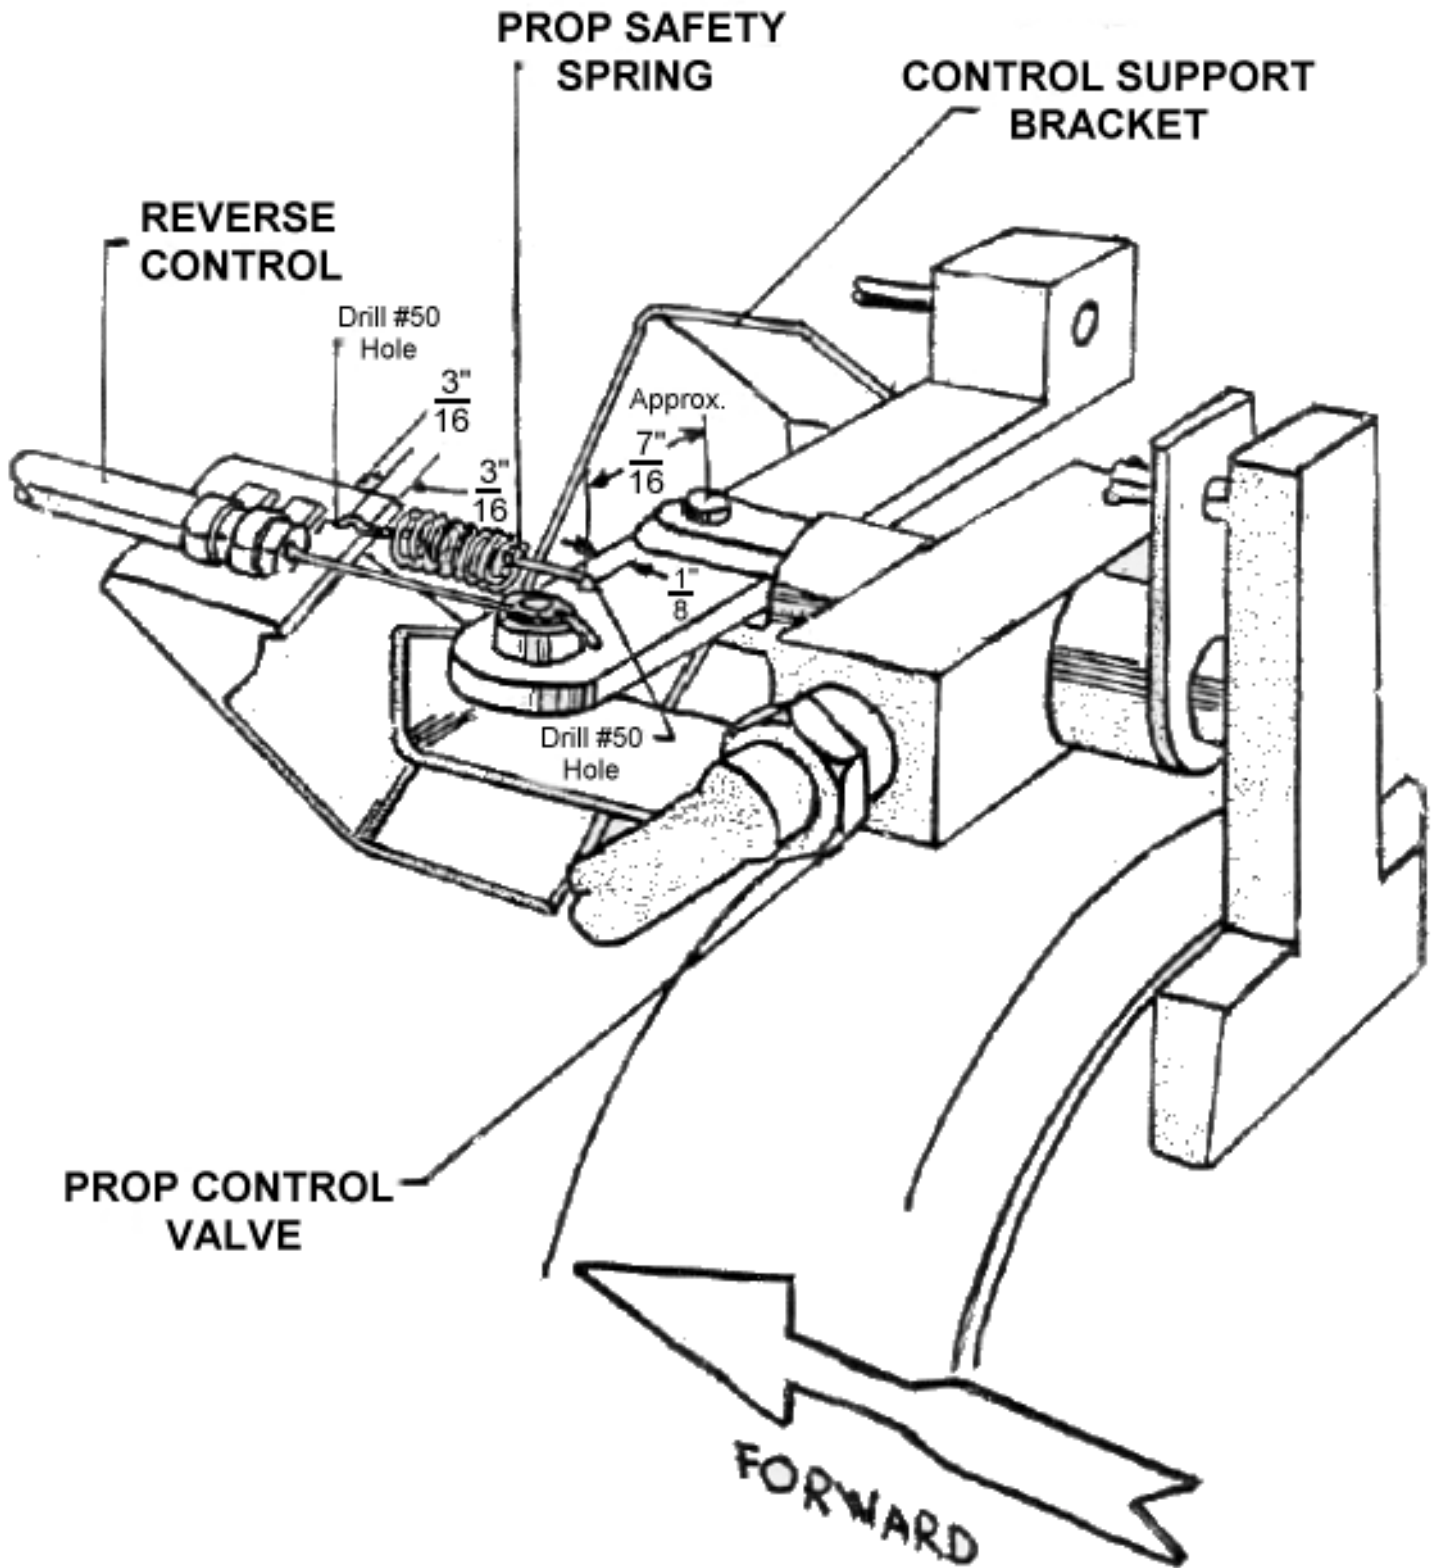
Figure 1

To install a safety spring to prevent the propeller from inadvertently going into reverse pitch in the event of failure of the reverse control wire (cable).

1. Unlatch and lift top engine cowl.
2. Drill hole with No. 51 drill in each of two locations shown on Figure 1.
3. Install SK-18837-1 spring.
4. Due to variations in the internal friction of the propeller control valve, it is suggested that the reverse control wire (cable) be temporarily disconnected, after the safety spring is installed and running the engine with the propeller pitch control in both high and low pitch to check the effectiveness of the safety spring in preventing the propeller from going into reverse pitch.
5. Reconnect the reverse control wire (cable).
6. Make complete ground check of propeller operating controls.
