REPUBLIC AVIATION CORPORATION
FARMINGDALE, LONG ISLAND, NEW YORK
• • • SERVICE DEPARTMENT • • •

No. 58

LANDING GEAR TORQUE TUBE ASSEMBLY

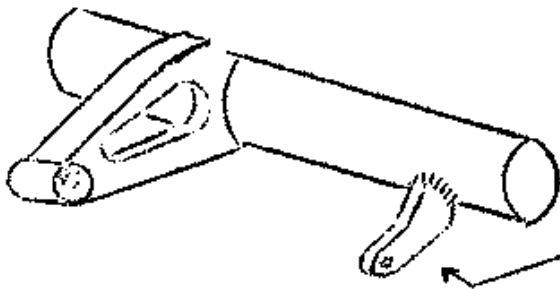
There have been a number of failures of the Landing Gear Actuating fittings. An examination with a 20X magnifying glass will determine if cracks at the base or in the weld are present. The item number is 1110 for the Torque Tube and Actuator Assembly. (Electrol, Inc, Drawing Number A5110).

**FITTING THAT FAILS.
HYD. ACTUATING CYLINDER
ATTACHES TO THIS FITTING.**

A recommended repair is to grind off all existing weld down to parent metal and arc weld with nickel steel rod, building up the bead around the fitting.

The above inspection is to be complied with immediately.
