## Flap Hinge-Spar Repair

### Description:

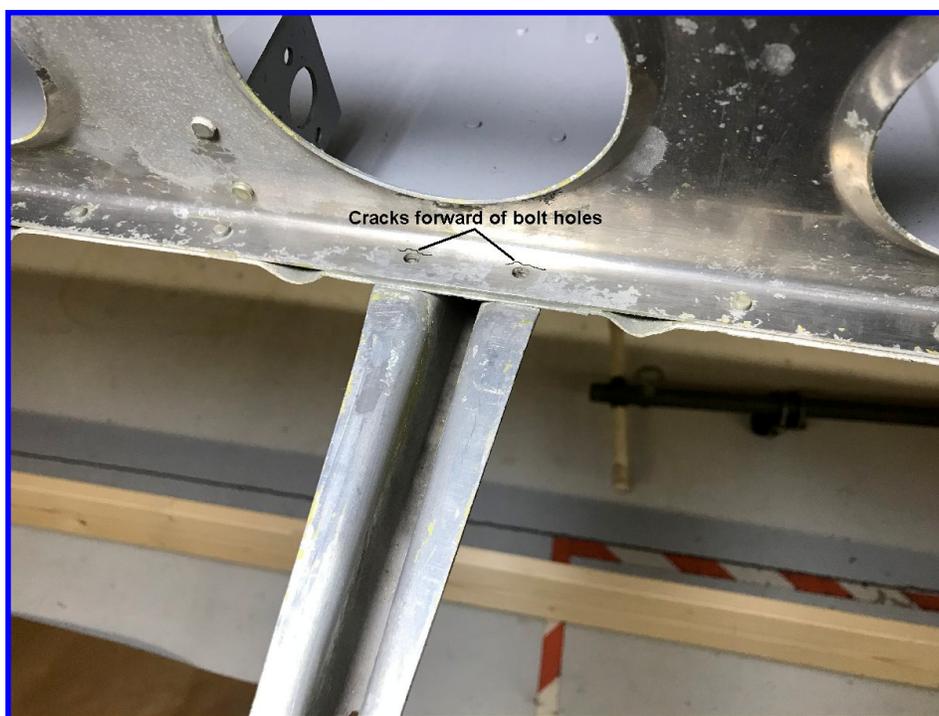
After removing the flap hinge hardware for wing painting, two small cracks were evident just ahead of the hinge bolt nuts on the outer flap hinge. They would be almost impossible to see without the hardware (hinge nuts and bolts) removed. The cracks are on the bend at the trailing edge spar. How they happened is hard to say but I suspect the flaps were subjected to overspeed at one time or another or perhaps there was some harmonic vibration in that hinge area. Who knows? Anyway, the crack must be addressed but how? The cracks were right where the bend is on the aft spar and is impossible to stop-drill. Fortunately the rear spar above the outboard hinge had plenty of area to form a patch, as shown below.

View of center flap hinge. Cracks were found on the outer flap hinge.

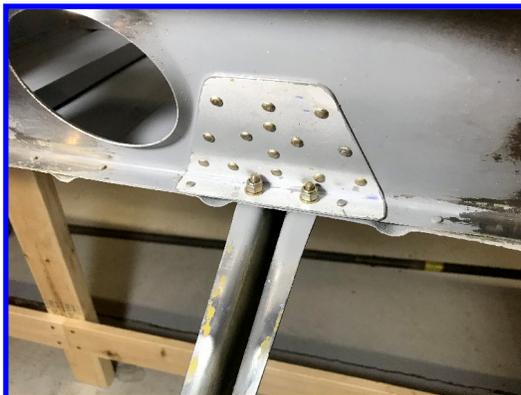
Completed patch with hinge hardware installed.

Use Cleco clamps or "C" clamps to hold the patch in place and be sure the patch fits tightly against the spar and spar flange. Using a #30 drill bit, drill the rivet holes through the patch and spar as shown below. Two rivets are installed through the spar flange and, along with the hinge mounting bolts, will hold the hinge and patch flange in place. Remove the patch and de-bur the holes in the spar and patch on both sides. Cleco the patch in place and start riveting. A rivet squeezer can fit into the trailing edge lightening holes and can be used for most of the rivets, however, a rivet gun and bucking bar will need to be used on a few of the rivets.

After the patch is riveted in place, prime and paint it as required. Check your other hinges for cracks and repair as necessary. Some Seabees have a small rectangular doubler on top of the spar flange, which indicates a problem must have existed previously. It is well worth removing the hinge hardware and inspecting for cracks on all the flap hinges. The aileron hinge area doesn't seem to have this problem, at least not so far.
