## Check your H-Bracket (Republic Part Number 1112)

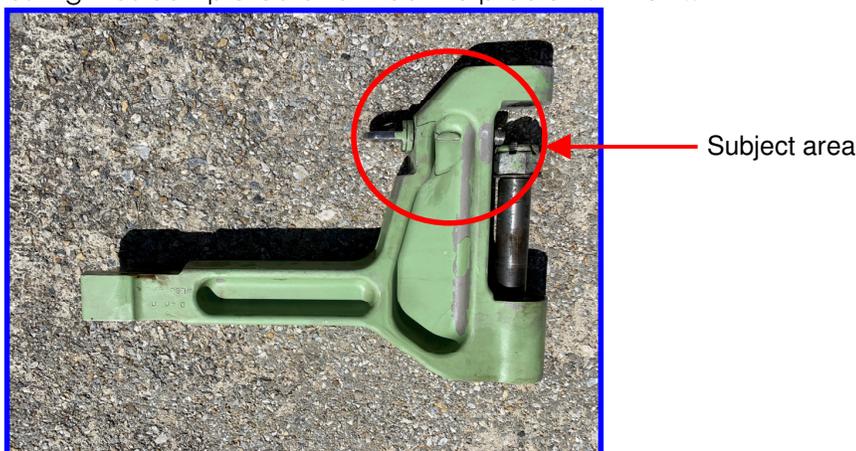
H-Bracket as removed from landing gear mechanism

**Warning:** Do not attempt to weld the H-Bracket to repair it! This can weaken the bracket and you will be right back on the hull stands wondering what the heck happened.

Inspect the main gear mechanism at least during every annual inspection. A strong flashlight and a mirror will have to be used to inspect the aft section of the H-Bracket. Pay particular attention to the H-Bracket's pivot point where the main gear actuator is attached. There is also a tab on the upper section of the H-Bracket that should be inspected as well. This tab has been known to crack.

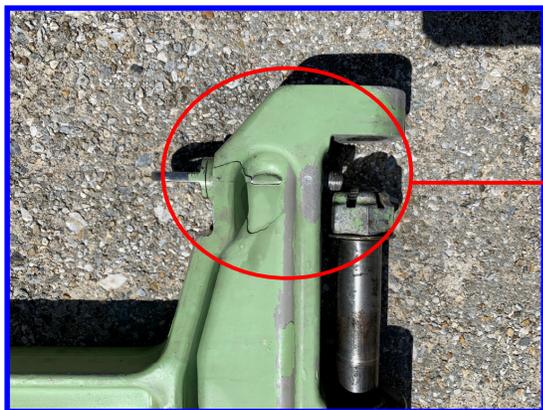
Closer view of H-Bracket

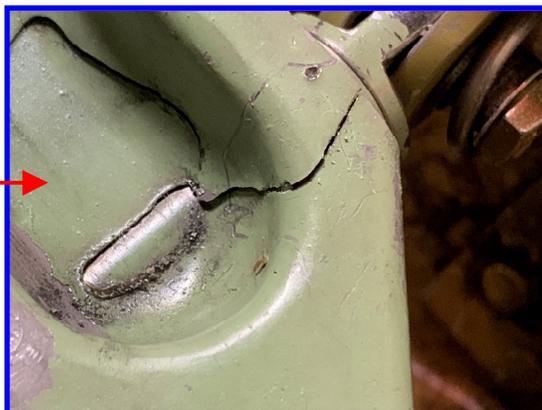
Really close view

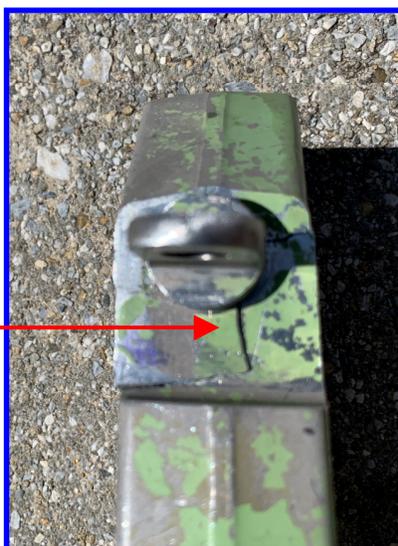
Crack

Top view of H-Bracket with previous repair
