## Check your Tail Wheel Microswitch

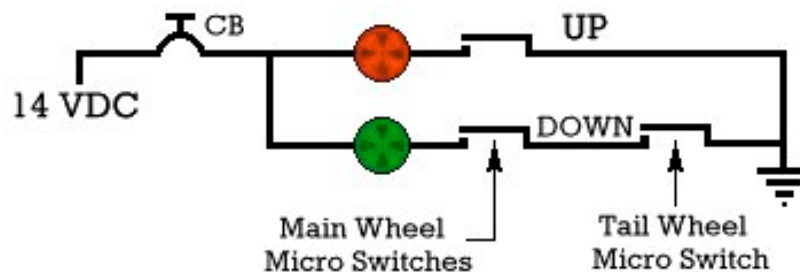
After trying three times to get a green light, I resigned myself to the fact that I was going to have to pull up the ramp and hope that perhaps the tail wheel was in fact down. As I pulled up the ramp I noticed an unusually nose high attitude as the main gear made its way up the gravel ramp. Okay, the tailwheel isn't down. (Remember that you need TWO switches to close to get a green light. Only ONE to turn on the red light. See illustration below)

After getting the tailwheel down and the Seabee back on dry land, I opened up the right and left-hand tail inspection covers. With the help of Jerry the local mechanic (sorry, I don't know his last name), we noticed the tail wheel microswitch had rotated 45° and was jamming against the tail wheel drum support inside the fuselage. This allowed the hydraulic pump (electric) to operate normally and shut off at its preset pressure of 800 psi. but without the tailwheel being fully extended. The small bulkhead was strong enough that it didn't get damaged when the switch came in contact with it and the switch was strong enough to take the punishment. Amazing.

What had happened was the jam nuts used to hold the microswitch in place had loosened and allowed it to rotate. After the fact someone else told me that the same thing had happened to him so consequently I am passing this along because I'm sure it could happen again. If this had happened on a hard surface runway the damage would have been significantly greater so check your tail wheel microswitch soon!
