Changing the tail wheel seal (P/N: 1414)

This procedure is used if your tail wheel seal is leaking. This will probably be caused by a dried out seal or foreign object damage (sand) in the seal cavity. It will take you a little while to complete but take your time and get your mechanic to approve what you do. You can check this on the ramp by filling the aft compartment with water and see if leaks. The part number is Garlock (Klosure) 53x2657 or National #455194. (Part number 1414 in the drawing below). These are available from your favorite auto parts supplier. You may have to order it and wait.

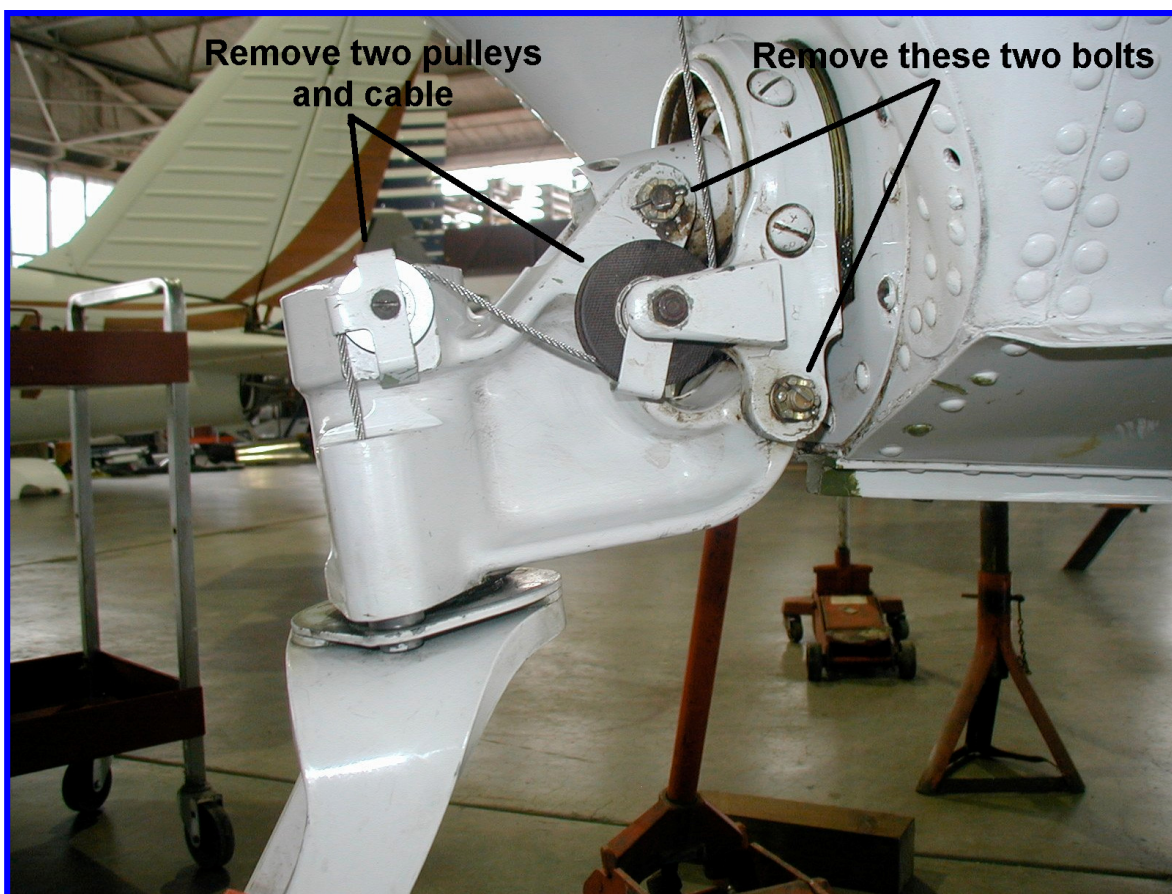
Tail wheel mechanism

The complete tail wheel assembly must be removed and stowed in a safe place until this procedure is complete. Start by removing the tail wheel and axle. Disconnect the locking tail wheel cable and remove it. Disconnect the steering cables if you have them. Remove the long bolt going through the tail wheel yoke (see photo). Remove the bolt going through the shock absorber piston. The whole yoke assembly should then be able to be removed.

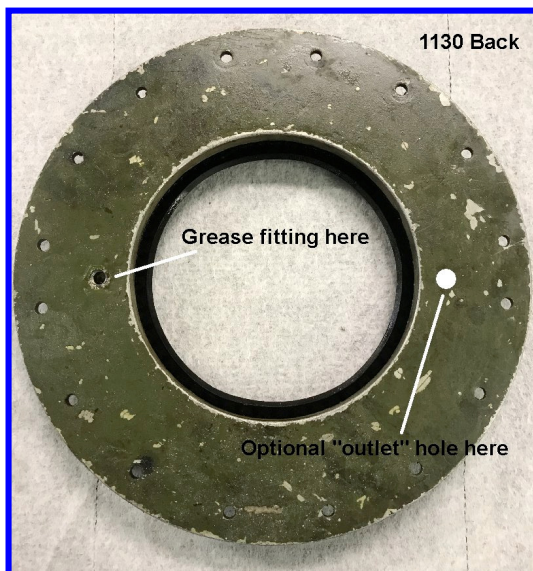
Note seal orientation.
Bronze bearing is under rubber seal.

Next remove the tail wheel bearing (P/N: 1130) attached to the airframe by removing the 16 AN23-10A bolts. This part has the seal in it. There is no other way that I know of to change the seal. Part 1130 may have sealer holding it in place so a little heat (propane) or solvent may have to be used to remove it. Once removed, inspect the bronze bearing for condition. If there is any gauging or deep grooves in it you might consider changing it. This part is a very precise fit and must be machined from bronze. The inner dimension of the bronze bearing MUST be precisely machined to match the outer diameter of the drum. It is also a press-fit into the bearing housing. See photos below.

Install the new seal with the rubber facing aft. The forward edge of the seal should be flush with the bearing housing. See photo above. The seal is a press fit so use caution and make sure it goes on straight. Use a hydraulic press or a block of wood to install it.

Optional hint: Four #43 holes can be drilled on the forward edge of the housing flange and tapped to a 4-40 thread. These are screwed in with washers to hold the seal in place. Use these in addition to the "outlet" hole on the right side. See photo above.

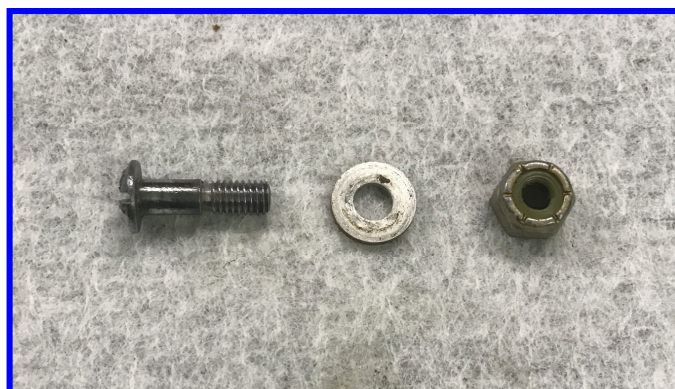
Hardware required to attach 1130 to airframe
16 each – AN23-10A clevis bolts
16 each – AN364-1032 lock nuts
16 each – AN960-10 washers

If a new bronze bearing has been installed, make sure the drum fits into it. Fine wet or dry sandpaper can be used if the fit is too tight. Reinstall the bearing housing using a good waterproof sealer (3M P/N: 5200) and the existing hardware but use new AN364-1032 lock nuts. Reinstall the drum (P/N: 1125) and the forward collar (P/N: 1145) using the existing hardware and new lock nuts. Reinstall the tail wheel actuator with the washer and NEW cotter pin. Install the tail wheel assembly and check the trailing angle. It should be 90°-95° from vertical when the full weight is on the tail wheel. This can be adjusted using the offset holes in the piston (P/N: 1128) or adding/removing rubber donuts. See photo below.
