## MAJOR REPAIR AND ALTERATION (Airframe, Powerplant, Propeller, or Appliance)

101 00011 50	on violation (dec	non son redetal Aviati	IUII A	Cf OI	1930).						
1. Aircraft	Make Republic				Model RC-3						
	Serial No.				Nationality and Registration			n Mark			
	1000				N5166B						
	Name (As shown on registration certificate

### Gear Position and Overboost Voice Warning Unit VW-1 Installation and Operation Manual KA-VWI

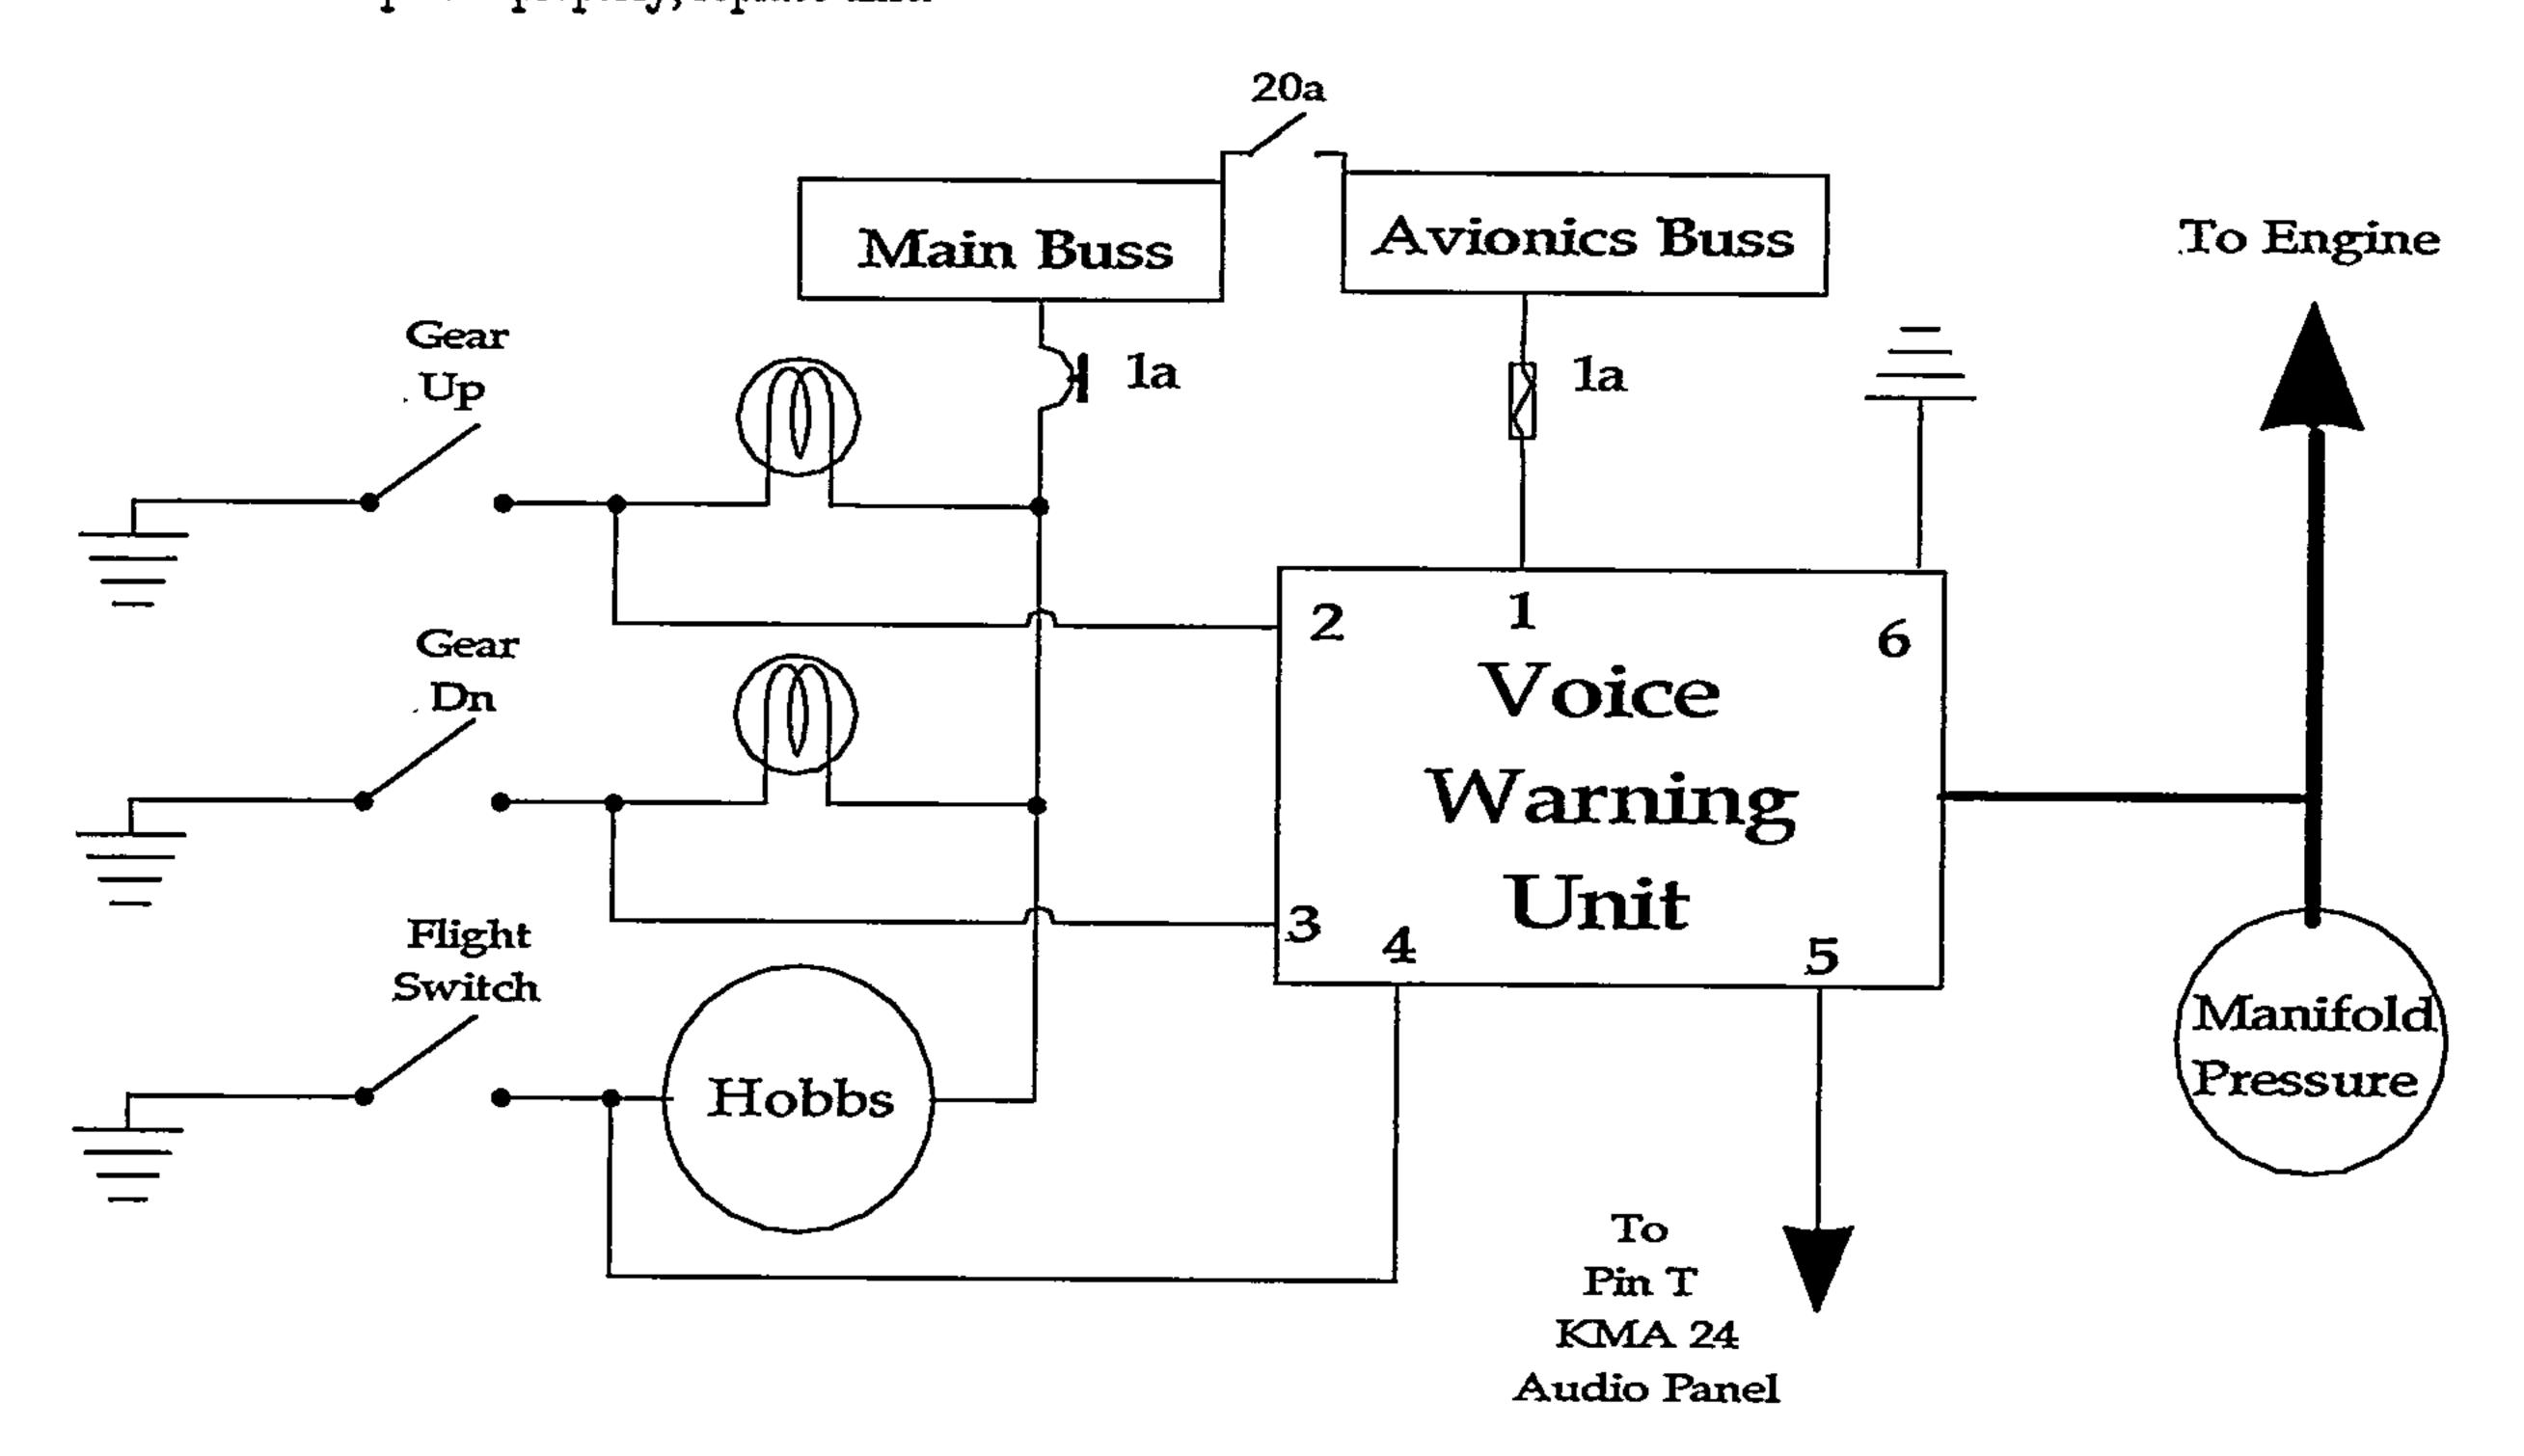
- 1. Find a suitable place to mount the unit. Attach to airframe with AN 525 1032 screws with self locking nuts or rivnuts and lockwasher. Reference AC 43.13 1A & 2A.
- 2. Using 22ga. Tefzel wire make electrical connections as shown in Fig. 1 as per AC 43.13 1A.
- 3. Plumb unit to manifold pressure line as shown in Fig.1. Reference AC 43.13 2A.
- 4. Test unit by supporting airframe to swing gear. Test overboost function by disconnecting line at manifold press. gauge "T" and pressurizing unit with adjustable calibrated airflow of 42inhg.
- 5. Operation of warning unit is automatic.
- 6. At each 100hr/annual inspection inspect unit for security and operation.
- 7. If unit fails to operate properly, replace unit.

- 2. Description: Installed KA-VW 1 Voice Warning unit behind instrument panel. Warning unit detects and warns pilot through aircraft audio panel of gear position before landing and of engine over boost condition. Unit ties in to aircraft electrical system as per attached drawing and is fused with a 1 amp fuse located in fuse panel. Over boost warning is detected by manifold pressure that is connected to a "T" fitting on manifold pressure gauge. Malfunction of unit does not affect landing gear position indicator lights or manifold pressure gauge. Reference attached sheet. All work done in accordance with Kenair Voice Warning installation and operation manual KA-VW1 rev.2, dated 7-25-99, AC 43.13 1A, Ch. 11, section 2, para.424, 429, section 3, para. 442, 443, 445 thru 451, fig. 11.7a, section 7, para. 514 thru 520.
